# Manhole Inspection Summary

Manhole # S15EE2024MH

**Location** Address: **2100 WESTERN RUN DR**

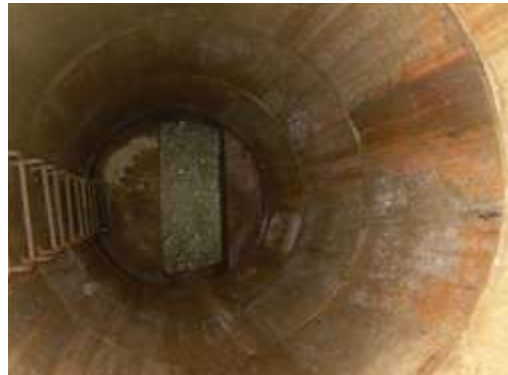
Top View

Corbel and Barrel infiltration. Evidence of surcharge - Bench debris.

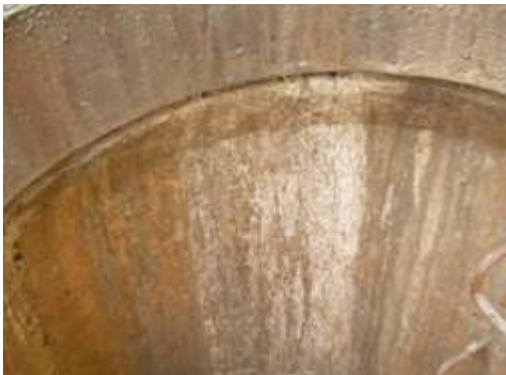
Defect

**Frame** Offset: **0** (in.) Condition: ☐ Sound ☐ Cracked ☒ **Leaks**

Infiltration: ☐ None ☒ **Joint** ☐ Cracks ☐ Mortar ☐ Roots ☒ **Wall**

Frame leaks. Corbel infiltration.
